TAC TEST 70A-057F

FOAMED-IN-PLACE HELMET

FINAL REPORT

July 1972

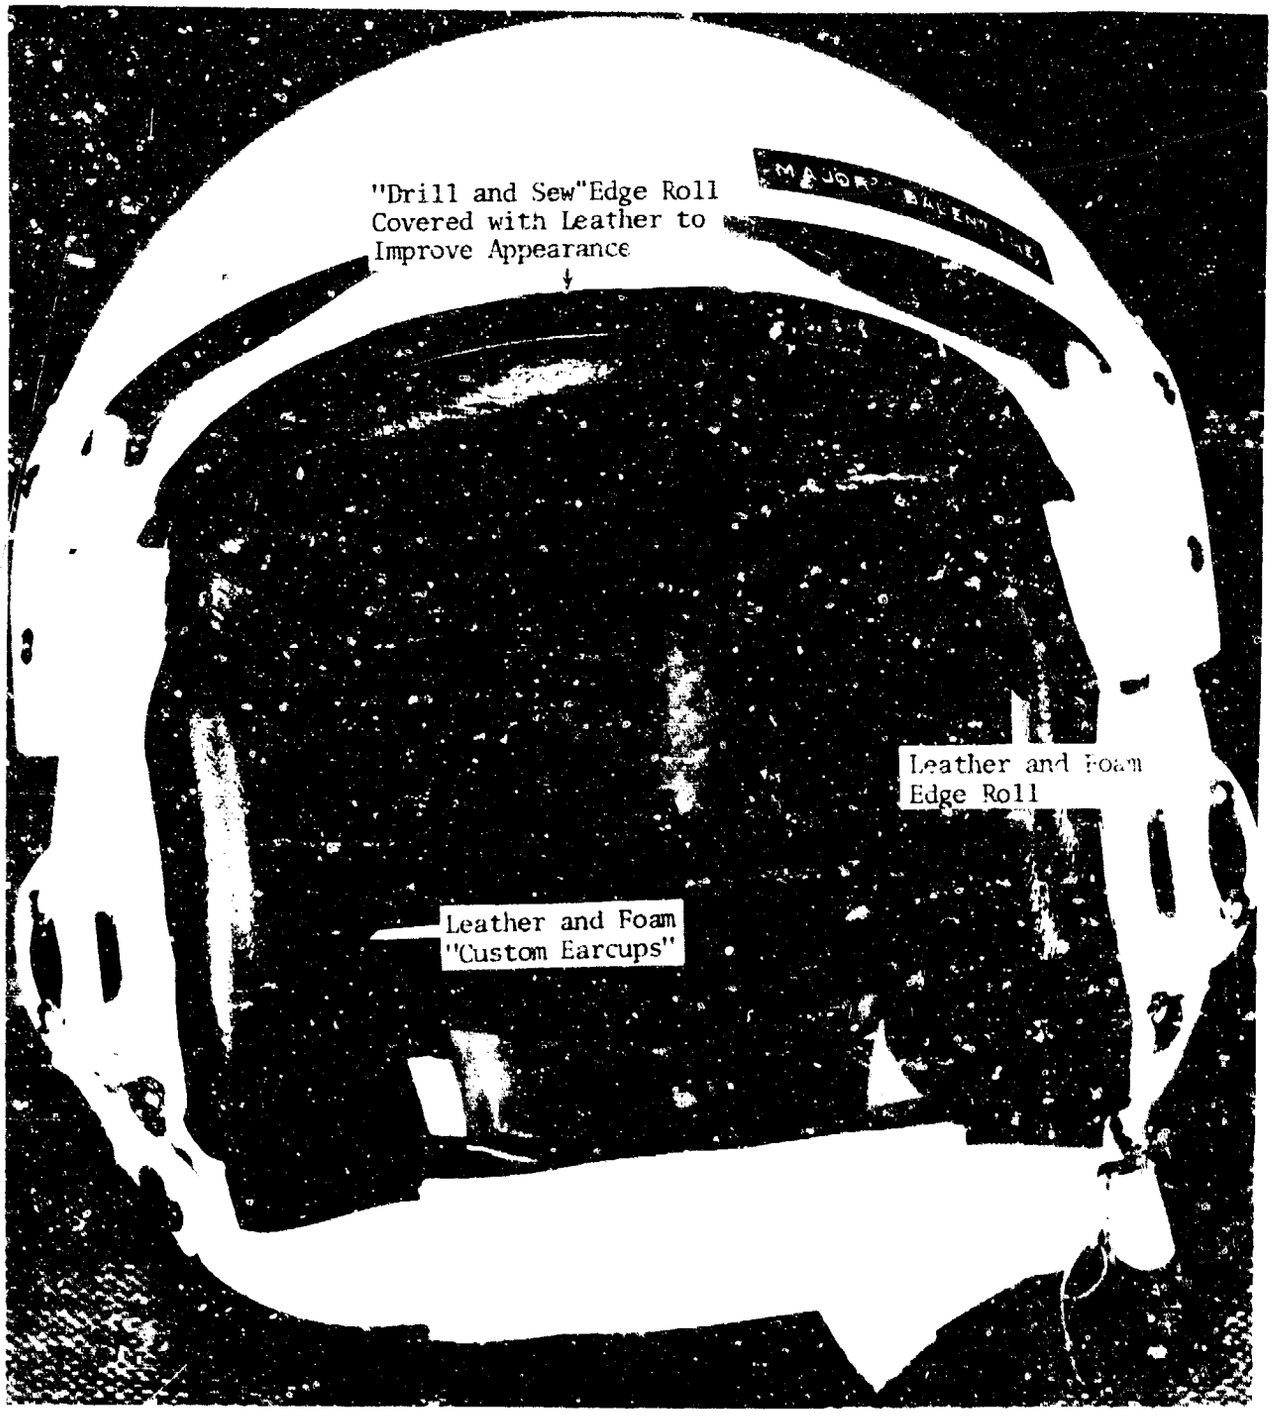
(i) Acoustical earcups (Figure 3, Annex C) were provided part-way through the test to replace the leather and foam custom-made earcups (Figure 1, Annex C). The latter were time-consuming to build and provided marginal sound attenuation. While the acoustical earcups did provide the required sound attenuation, they were unacceptable due to aircrewmen discomfort. For numerous aircrewmen, the earcups were too tight (due to the thickness of the cup) to wear at all. Difficulty in placement, the small size of the ear opening, and an excessively thin comfort pad made them very uncomfortable for the majority of aircrewmen who evaluated them.

(5) The drill-and sew procedure used in the cutom fit helmet program produced a helmet edge roll superior in comfort and appearance but took two to three times longer than required for installation of the rubber edge roll (Figures 1 and 4, Annex C).

Figure 1. Finished Product with Leather and Foam Edge Roll and Earcups.

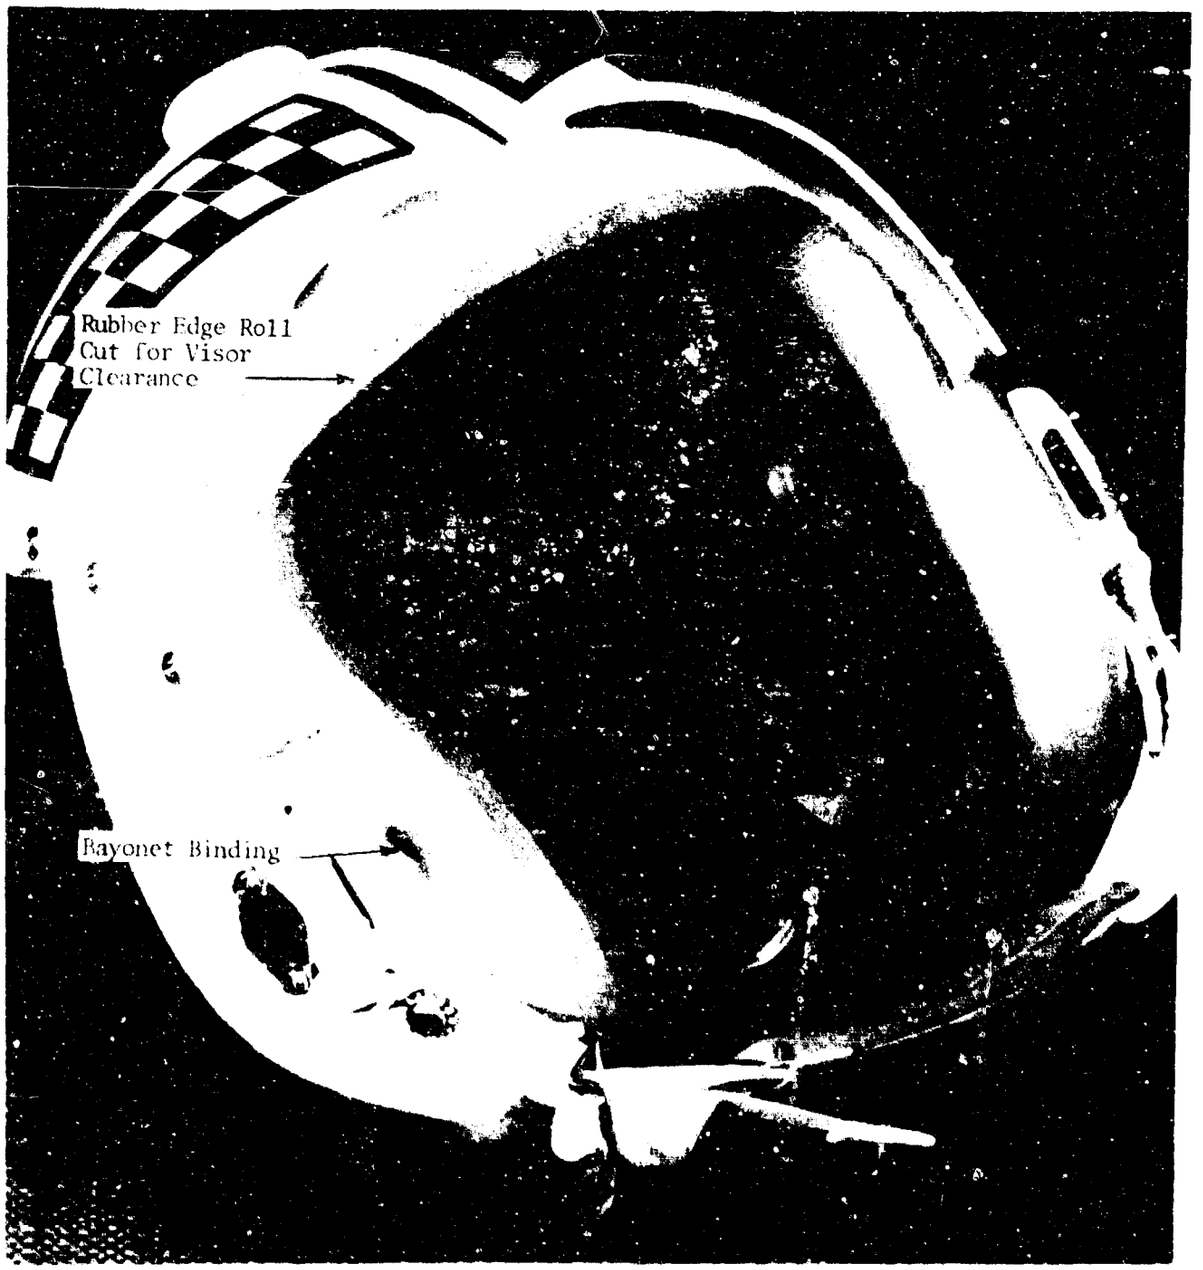
(h) A rubber edge roll (Figures 2, 3, and 5, Annex C) provided to replace the leather and foam edge roll was unacceptable. On individuals with wide faces or high cheekbones, it had to be cut down to the point where very little padding remained (Figure 3, Annex C). It was also necessary to cut the edge roll to allow for operation of the visor (Figure 2, Annex C). The rubber was difficult to cut and the cutting produced a most unsatisfactory appearance. Difficulty was also experienced with bayonet binding (Figure 2, Annex C) unless another portion was cut away.

Figure 2. Finished Product with Rubber Edge Roll.

b. Develop, procure, and provide comfortable, adhesive-backed, leather covered edge rolls for retrofit on all Foamed-In-Place helmets.

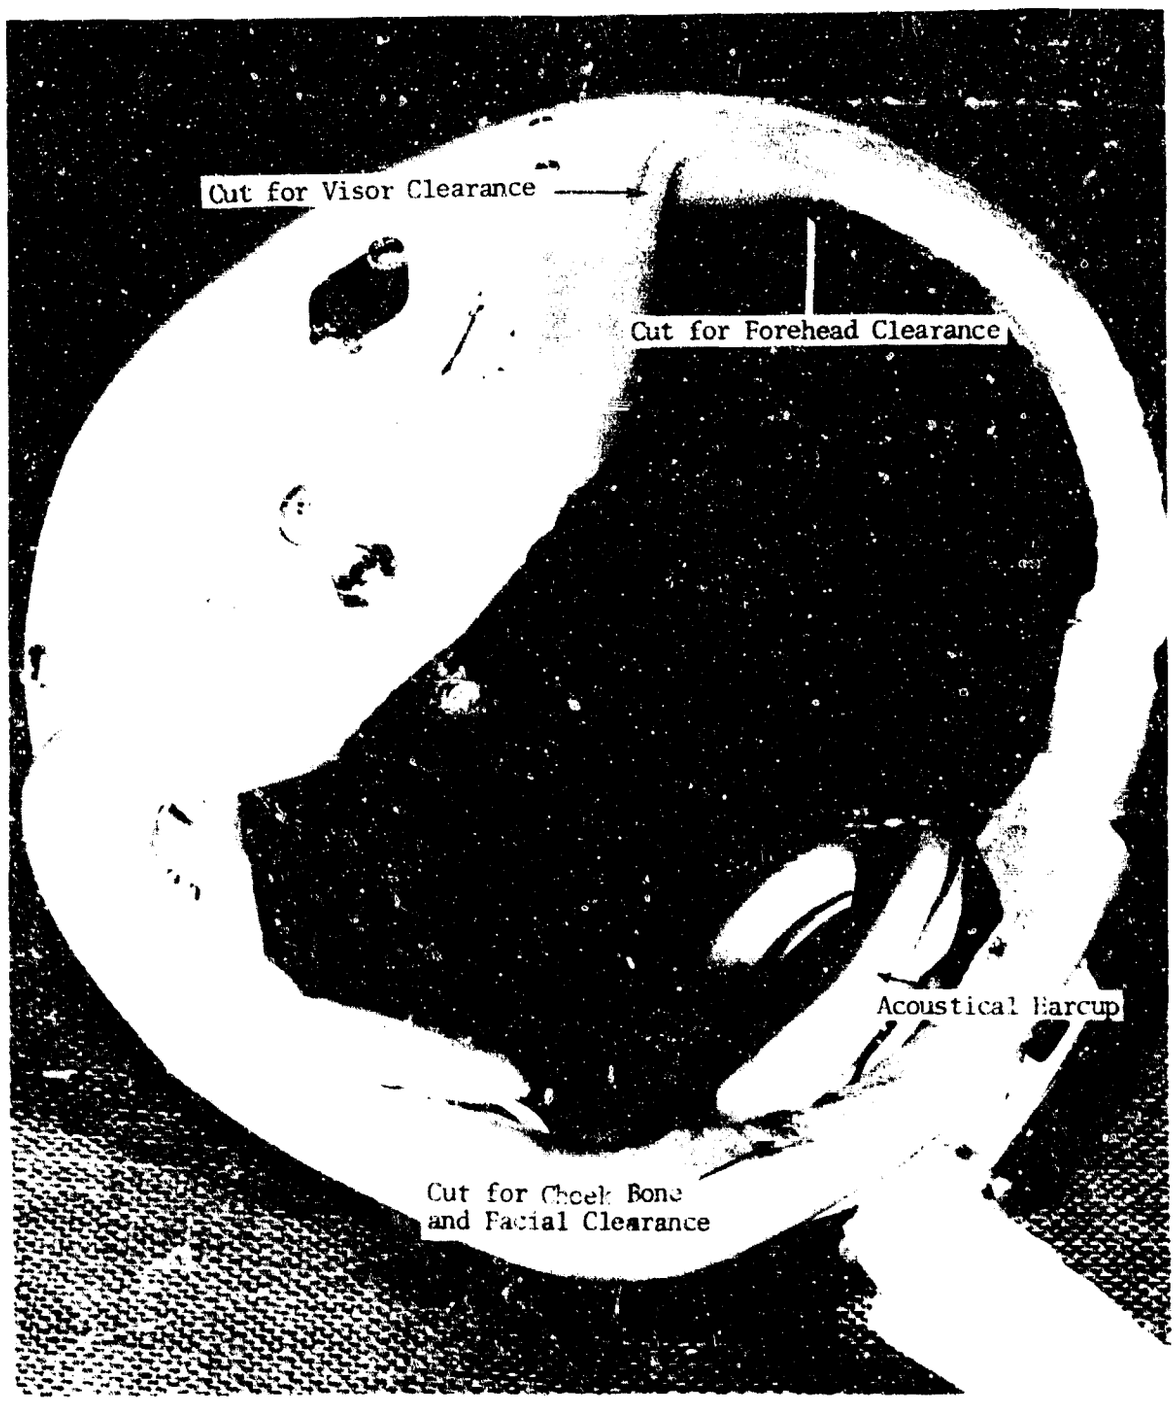
Figure 3. Example of Difficulties Encountered with one Rubber Edge Roll.

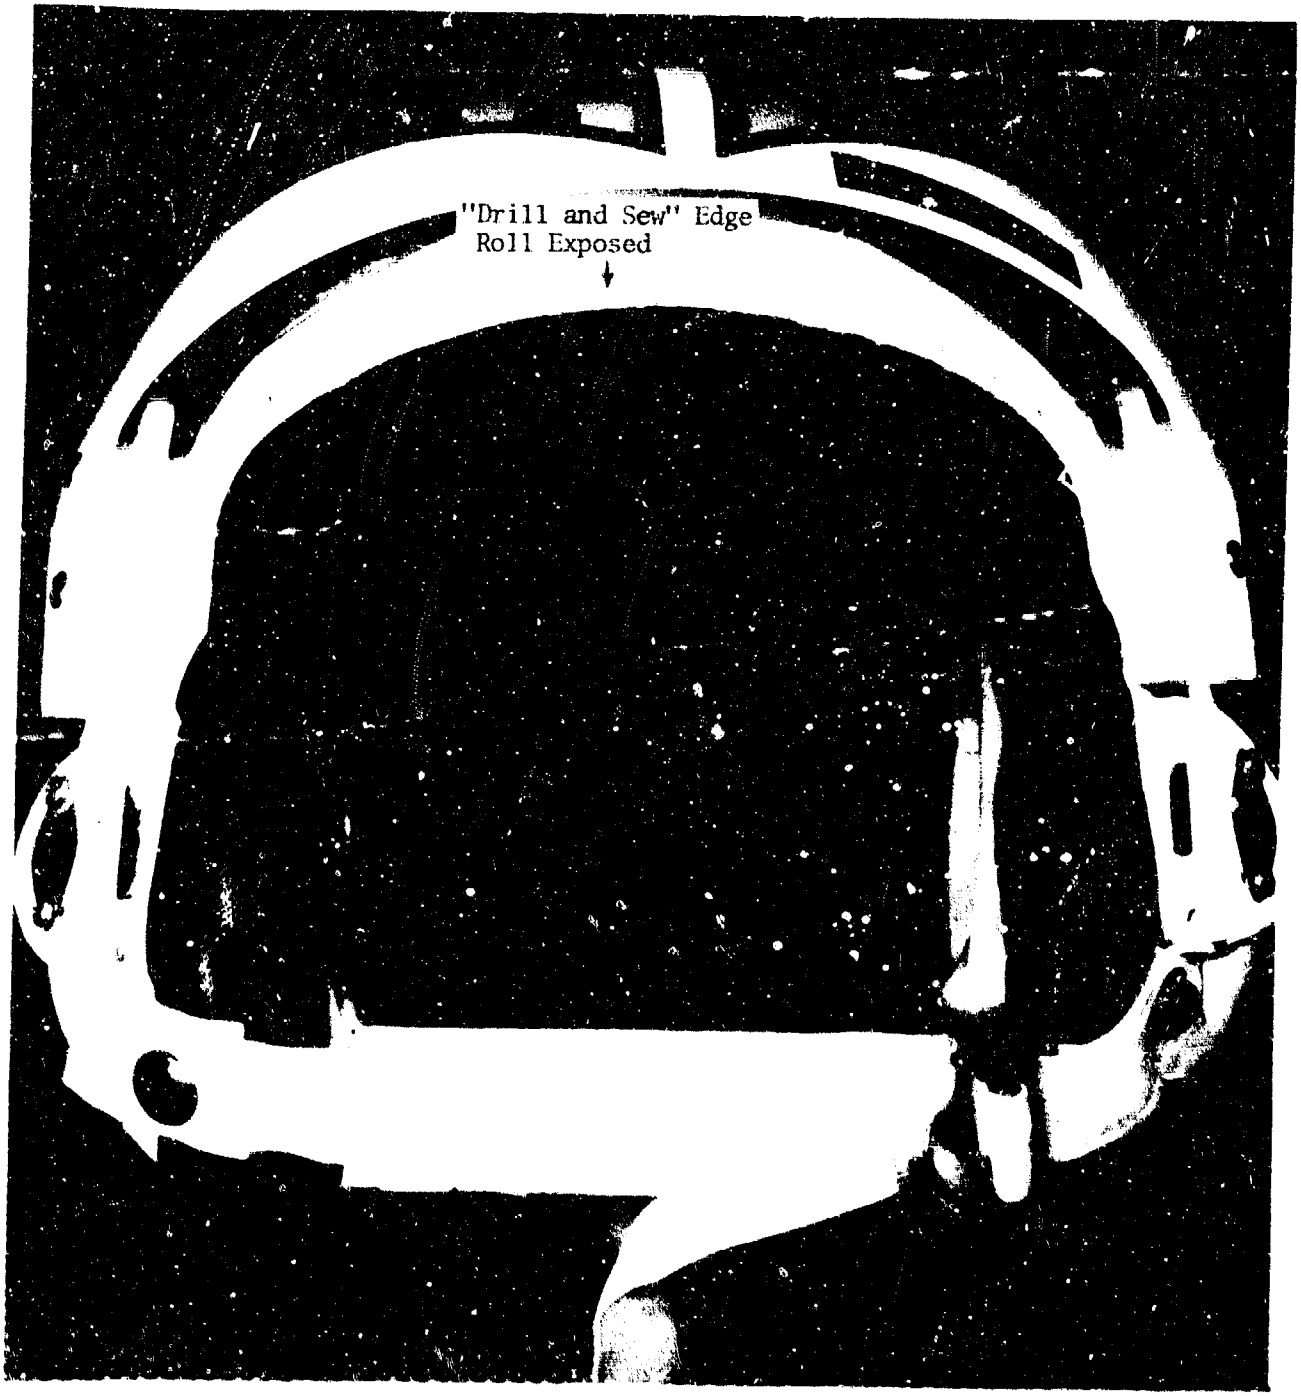
Figure 4. Finished Product with Leather Edge Roll and Acoustical Earcups.

a. Develop, procure, and provide comfortable acoustical earcups for retrofit on all Foamed-In-Place helmets.

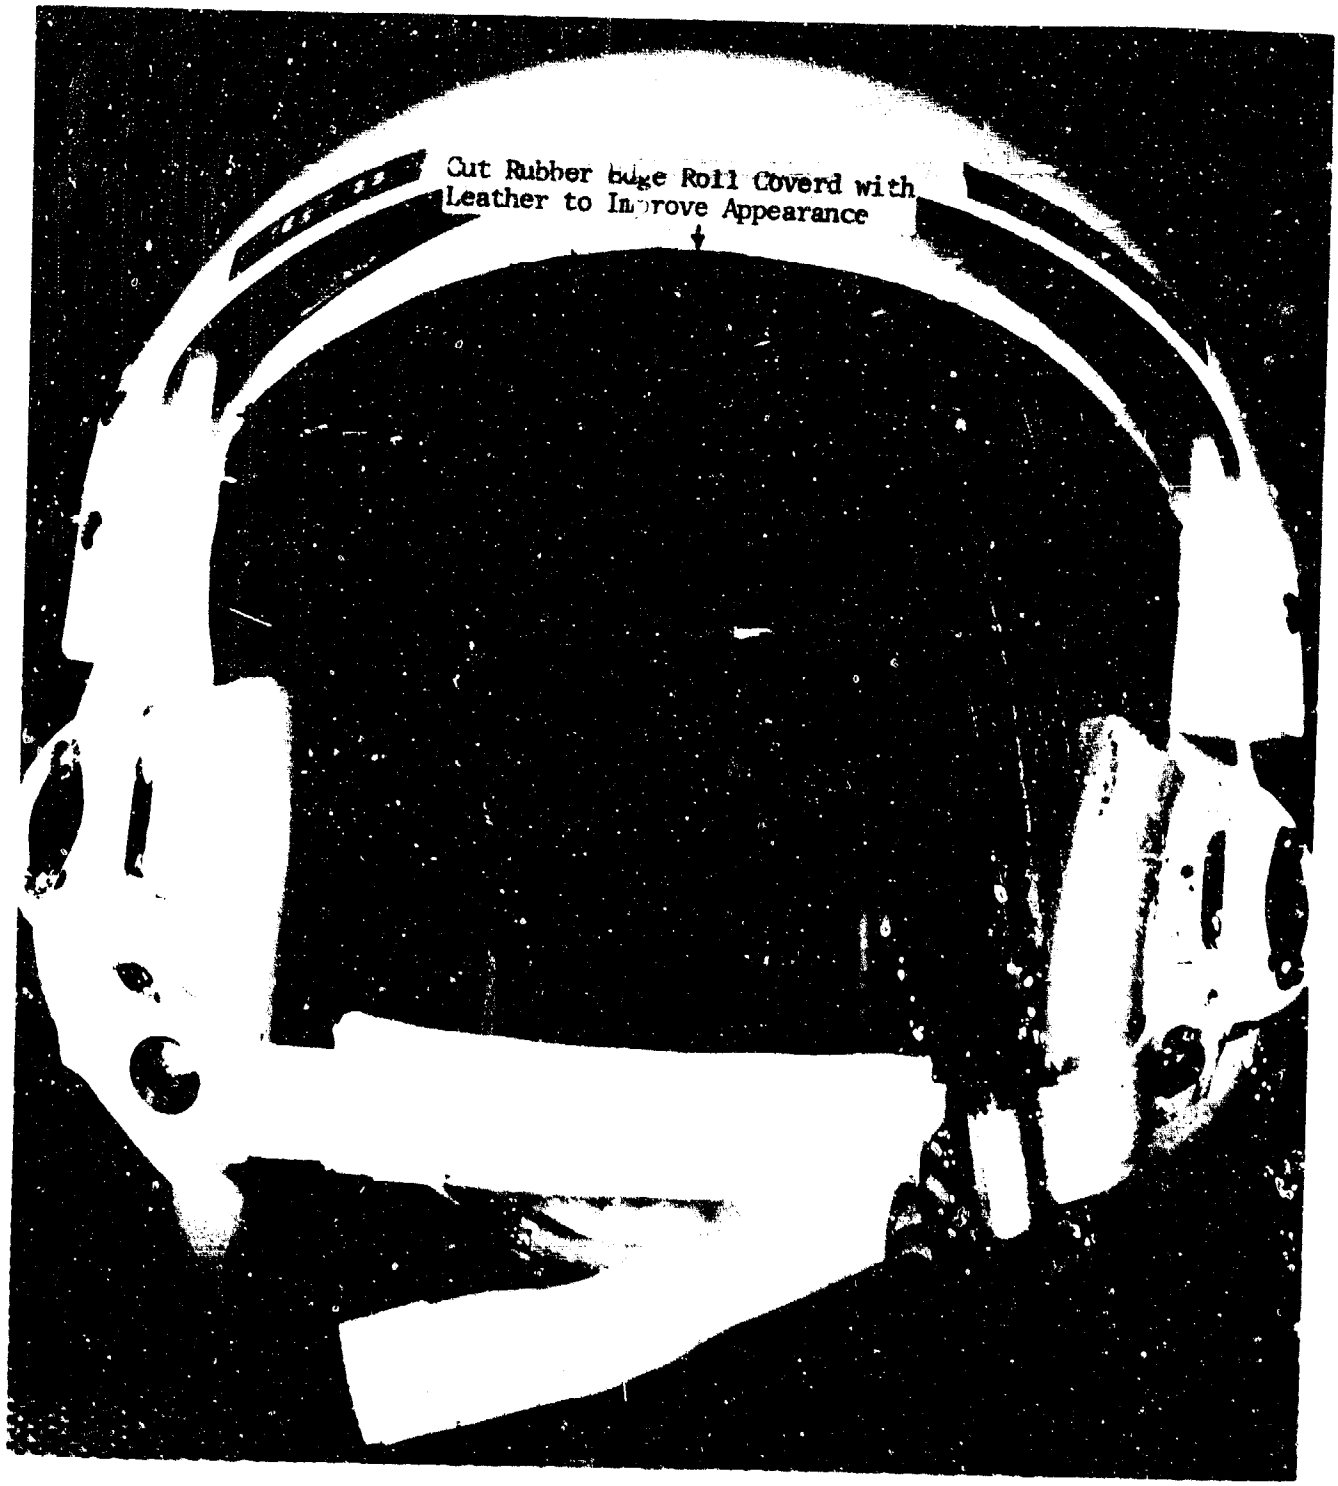
Figure 5. One Effort to Improve Rubber Edge Roll Appearance.

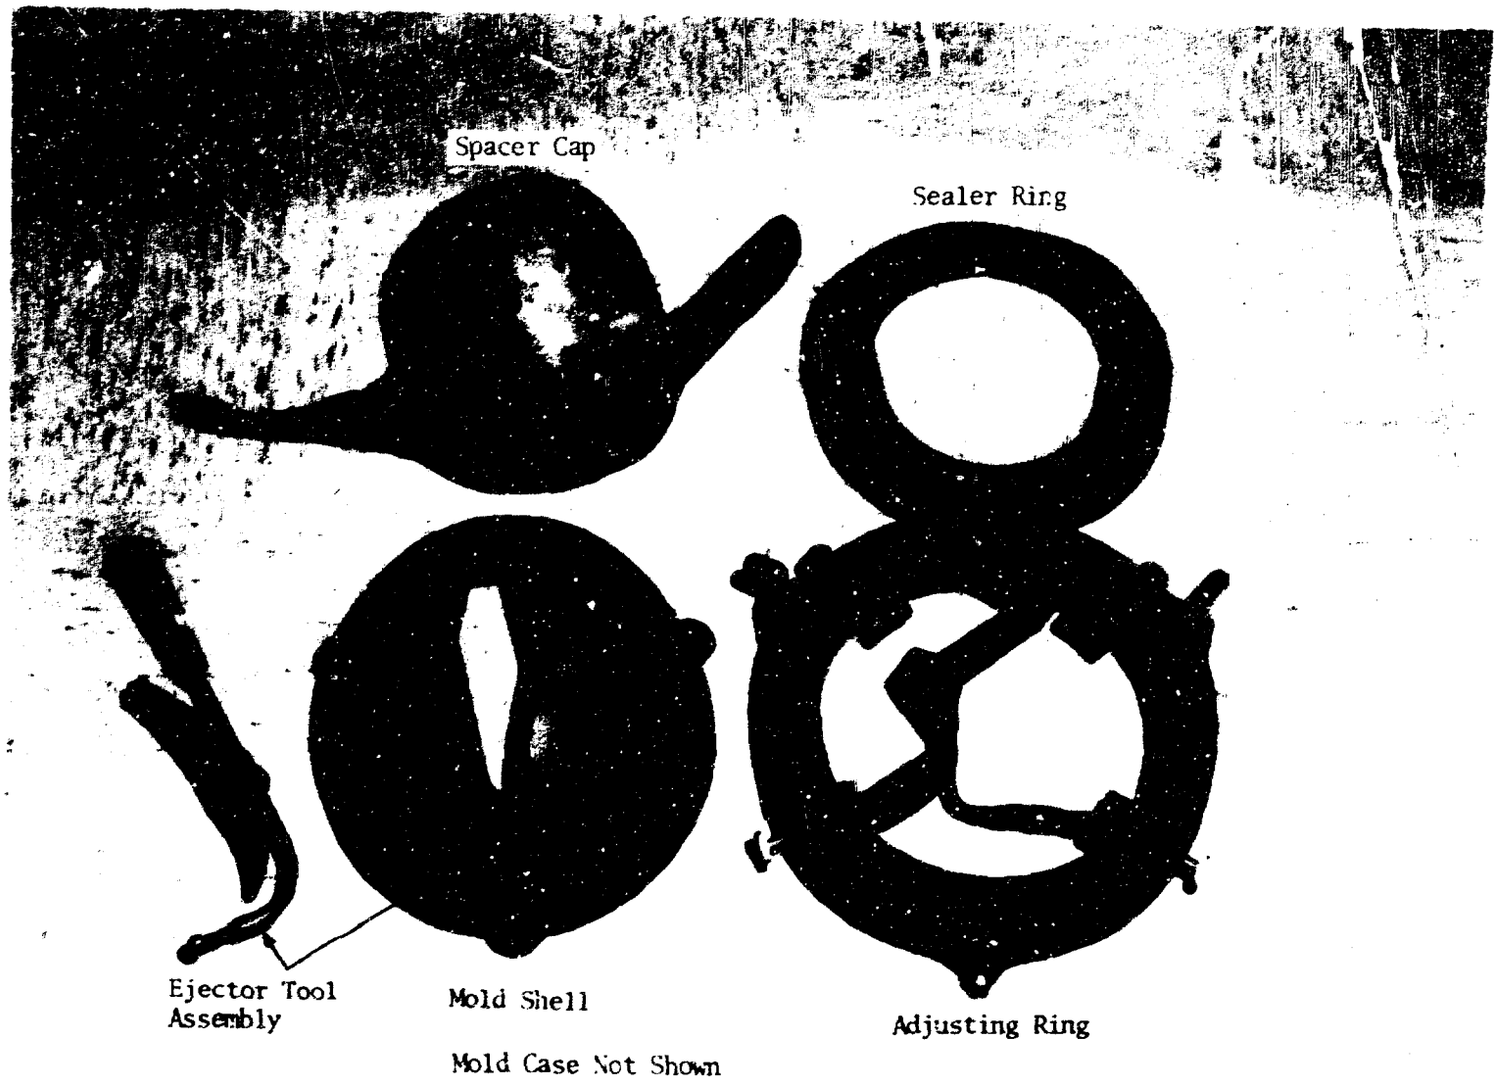
(a) The mold and its associated hardware (Figure 6, Annex C) was adequate. With proper instructions and practice, technicians had no problem fitting it to the aircrewman's head. Aircrewmen found the fitting and foaming process rather uncomfortable due to tightness of the sealer ring when in place on the head and because of the heat generated by the foaming process which was comparable to a hot shower. The whole procedure lasted only about 20-30 minutes. The addition of an extractor lever in later molds further reduced the time and effort required to get the foam liner out of the mold.

Figure 6. Mold Hardware.

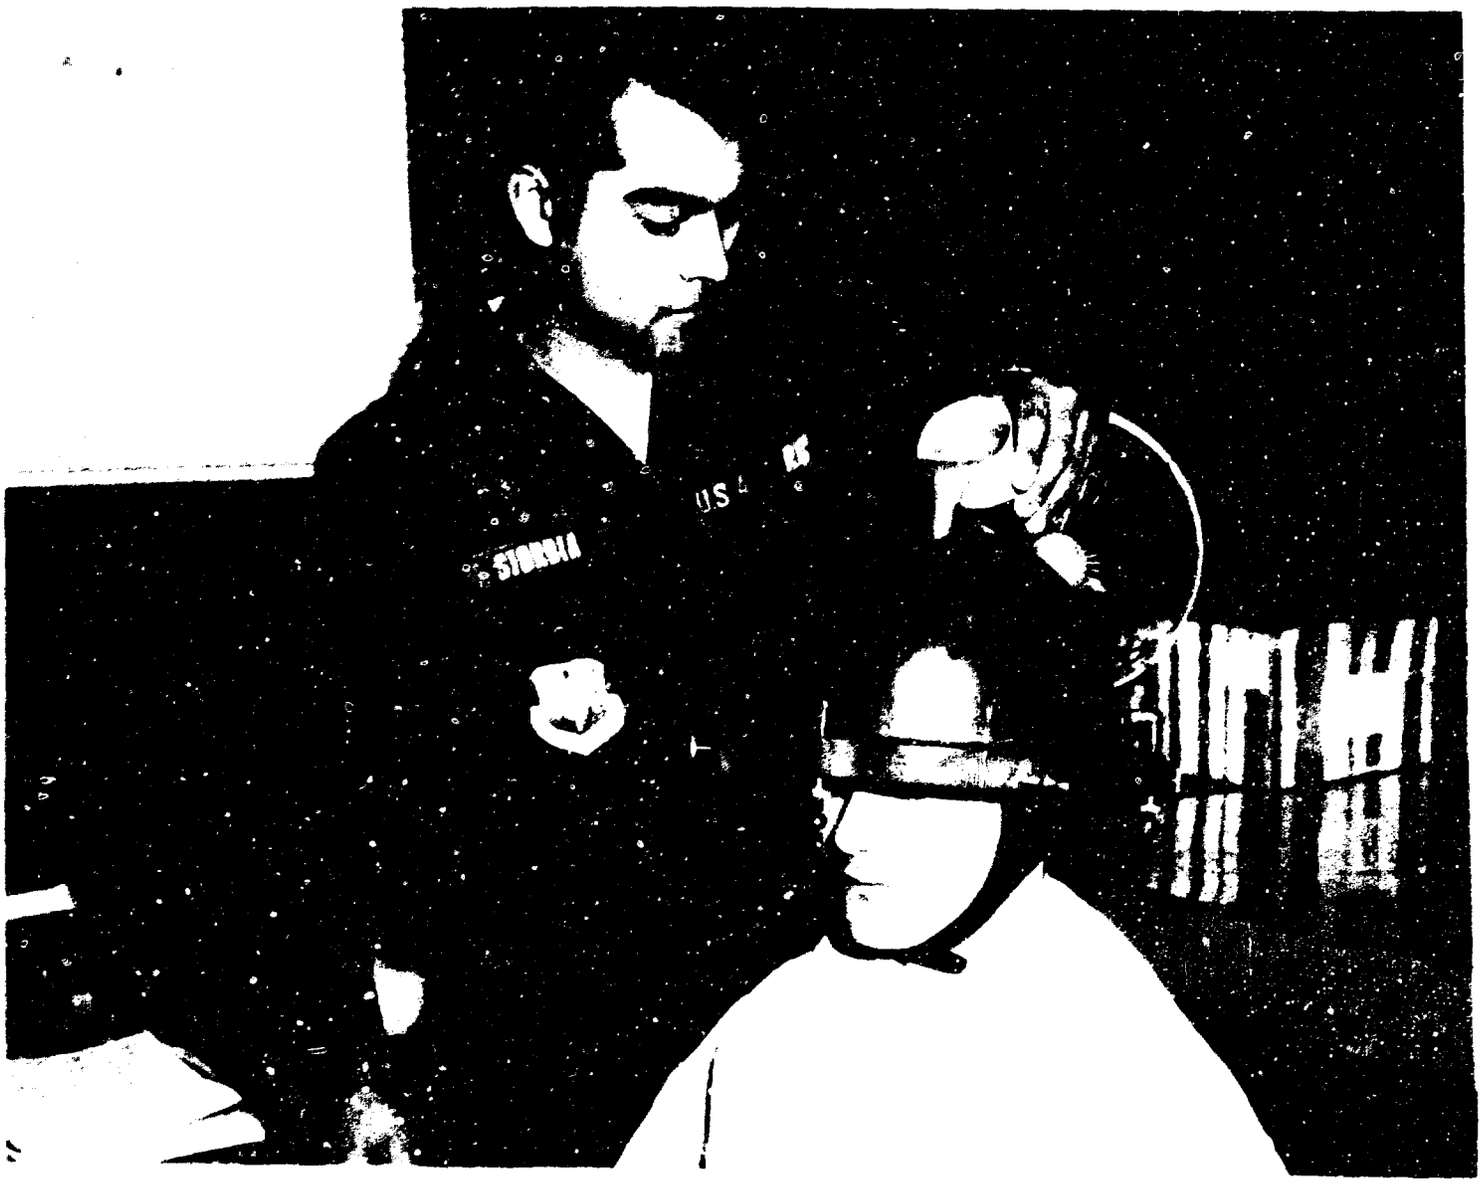
(2) The mixing of the chemicals and the "just-right" time to pour the rising foam from the cup into the mold was a problem at first (Figures 11, 15, and 16, Annex C). Four or five attempts were usually required to obtain proficiency in this technique.

Figure 11. Foam being Poured into Mold.
